Kucina

UNGARO Srl

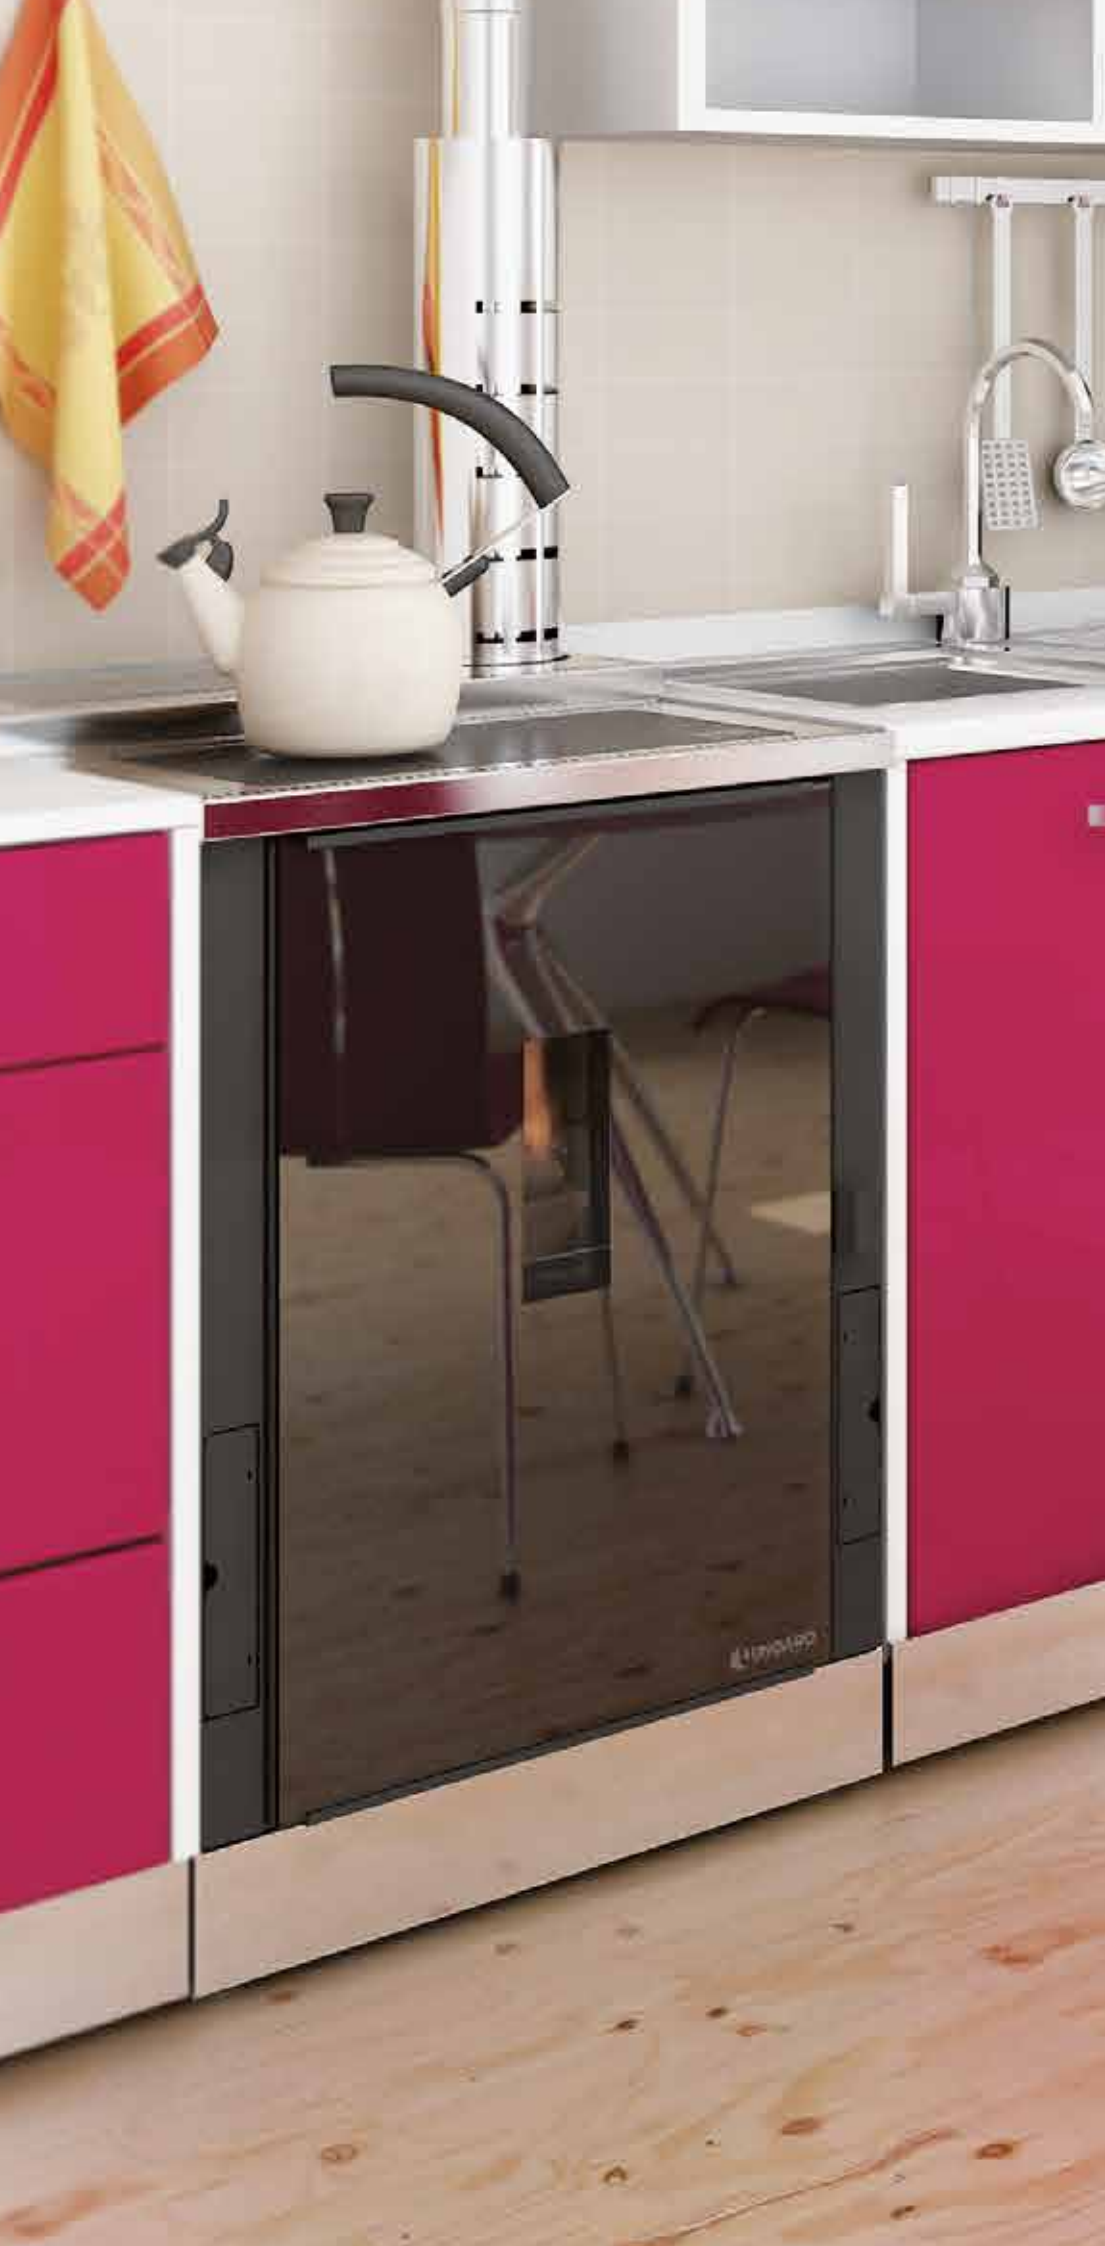
| Entrata aria comburente / Air Intake Pipe / Entrada de aire comburente/ Entrée d'air/ Primärlufteinlass | A | Ø 130 mm |
| Uscita scarico fumi / Exhaust pipe/ Salida de humos/ Sortie de fumées/ Rauchabzug | B | Ø 80 mm |
| Mandata impianto / Heating Flow / Envío calefacción / Départ chauffage/ Vorlauf | C | 3/4" |
| Ritorno impianto / Heating Return / Retorno calefacción / Retour chauffage/ Rücklauf | F | 3/4" |
